# LANDSLIDES IN SRI LANKA : SOME ASPECTS

**JINADASA KATUPOTHA**

*Department of Geography,  
University of Sri Jayewardenepura.*

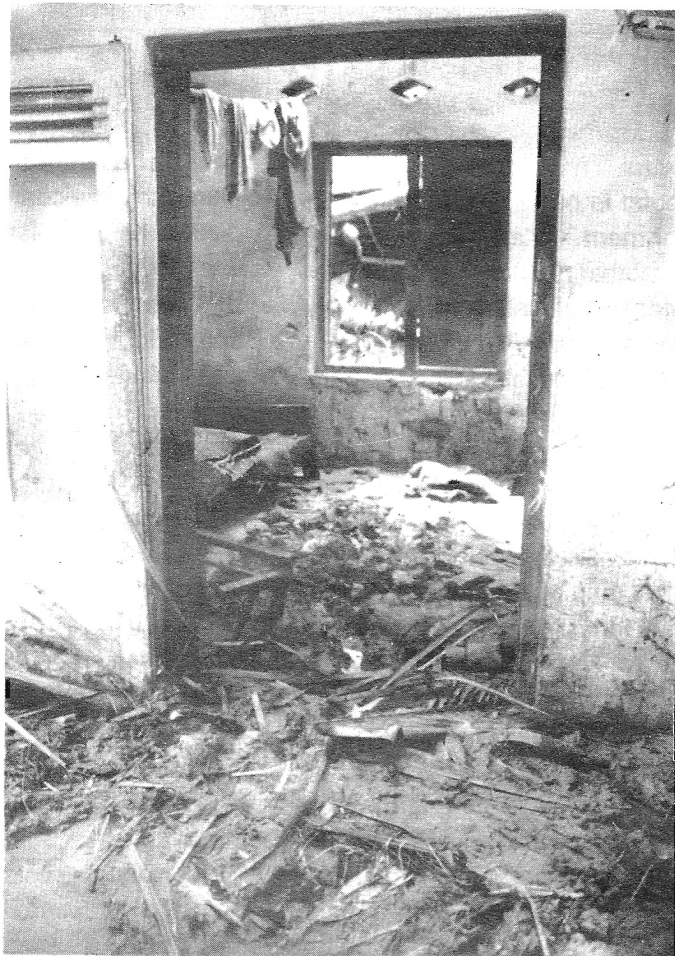
Plate 4: (A) Damaged rooms in one of the houses shown in Plate 3 (B). (B) rock and other debris of the same landslide of Plate 3.

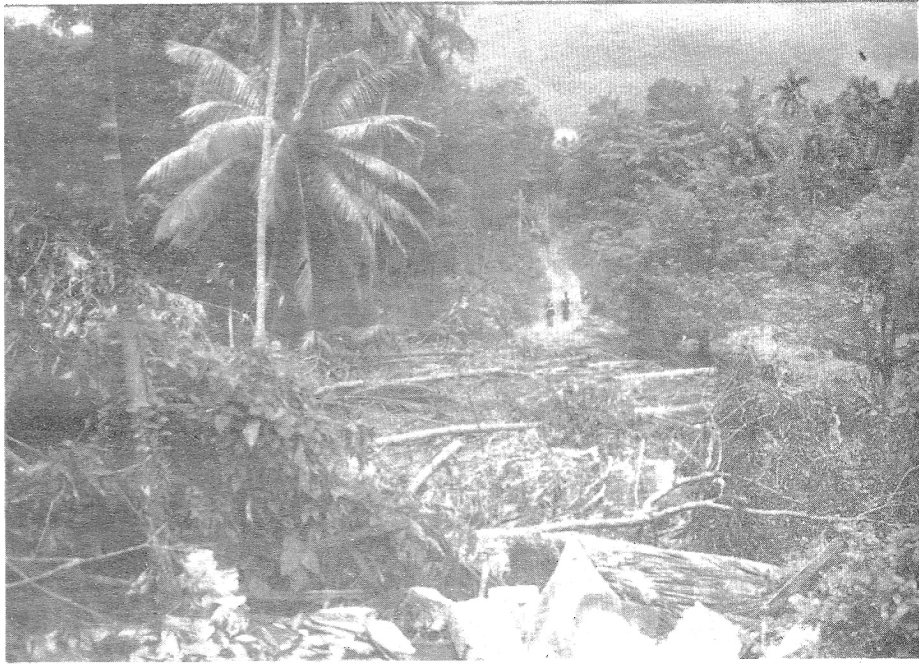
**Plate 3:** (A and B) Deposition of rocks, debris and earth by landslide in 1992 caused the damage of three houses and five deaths at Bulatsinhala (Kalutara district).

In 1989 also caused damage to the Kandy - Mahiyangana road (at Hunnasgiriya) by displaced debris and boulders (Plate 2.A). Slope slumping in several places of these areas appeared singly or as a combination of two or more types (Katupotha, 1991). Due to excessive rainfall between 25 and 30 May in 1992, a catastrophic slide of debris and rock blocks caused five deaths, and three families were rendered destitute at Bulatsinhala in the Kalutara district (Plates 3 and 4). Based on a recent study, Katupotha (1992) indicated that the occurrence of landslides has increased in areas of the Provincial Secretariat Divisions at Ridigama and Ibbagamuwa in the Deduru Oya basin; Bulatsinhala, Matugama (Plate 2.B), Agalawatta, Ayagama, Elapata, Kalawana, Ratnapura, Kahawatta, Kuruwita, Pelmadulla in the Kalu Ganga basin; and Weligepola, Haputale, Godakawela, and Kolonna in the Walawe River basin. Landslides in these areas have altered the micro relief and causing changes in the flow pattern of streams either through damming or diversion and deposition of rock, debris and earth.
